**Flood Control Project Maintenance
Levee Inspections**

Fall 2016 Levee Maintenance Deficiency Summary Report

Sacramento River Basin

Lake County Watershed Protection District

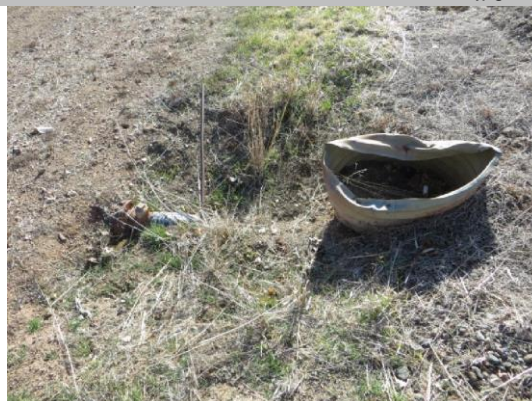
Photo 1 of 2 : UCIP_FA_2016_26943_49782.jpg

Comment Code					
Inspector Comment					
FS_ID:26943					
DS_ID:21193					
EP_NO: 5237					
Repair Type: Non-Urgent					
Crossing Status: Found					
UCIP Comments: Pipe appears abandoned and should be done so properly.					
FIELD_STRUCT_DESC: *ABANDONED* 6-inch steel pipe possibly sleeved through an 8-inch steel pipe, 3.0-feet below the crown. Siphon breaker in 24-inch CMP riser on the landward slope. Reinforced concrete cutoff wall at center of levee. Butterfly valve on the waterward side at pump on concrete base on the waterward bank, installed under Permit No. 5237 (1971). Pole on the waterward berm, with overhead power line supplying electricity to pump. Originally included in the 1961 O+M manual.					
FS Date: 1/9/2014

Pipe and siphon breaker visible on LS slope.

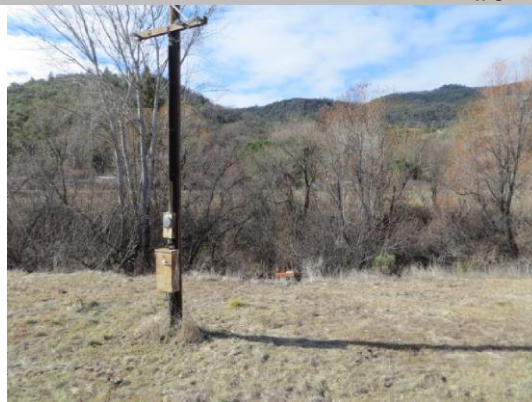
Photo 2 of 2 : UCIP_FA_2016_26943_49781.jpg

Power pole, meter, and pump visible on WS berm.

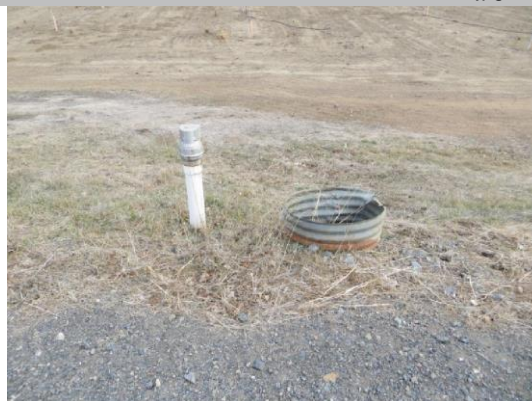
Photo 1 of 2 : UCIP_FA_2016_26946_49789.jpg

LM Start	0.84	Rating **	M	Issue No.	536
LM End	0.84	Issue Type +	En	Location *	LS
Category	Supplemental			GPS Latitude/Longitude	
				Start	End
Item	DWR UCIP Field Study			39.179534 °	39.179534 °
				-122.912512 °	-122.912512 °
DWR ID					
Comment Code					
Inspector Comment					
FS_ID:26946 DS_ID:21196 EP_NO: N/A Repair Type: Non-Urgent Crossing Status: Found UCIP Comments: Pump and pipe appear abandoned and should be done so properly. FIELD_STRUCT_DESC: *ABANDONED* 8-inch steel irrigation pipe through the levee, 3.0 feet below the crown. Siphon breaker in 24-inch CMP riser on landward slope. Pump on the waterward bank with a butterfly valve. Service pole on the waterward berm. (USACE-1961). This entry matches the Drainage or Irrigation Structure referenced in O&M manual (HLM 0.83). FS Date: 1/9/2014

Siphon breaker in 24-inch cmp riser with vent on LS shoulder.

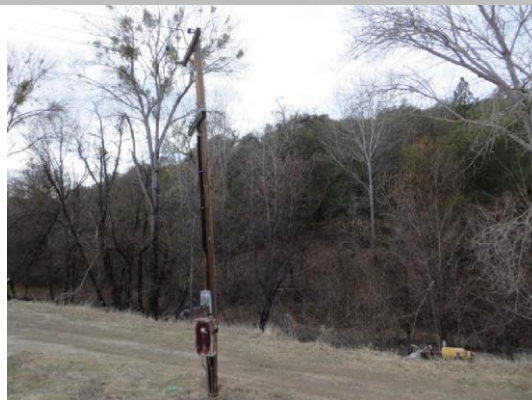
Photo 2 of 2 : UCIP_FA_2016_26946_49788.jpg

Pump, pole, and meter on WS berm.

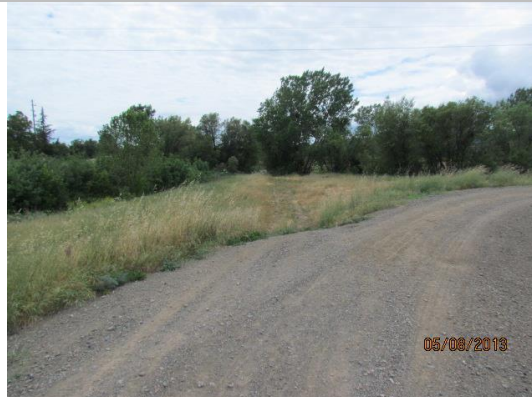
Photo 1 of 1 : FA_2016_NA0009_3_13_20160823_00007.jpg

LM Start	2.29	Rating **	M	Issue No.	13
LM End	2.29	Issue Type +	Ma	Location *	WS
Category	Earthen Levee			GPS Latitude/Longitude	
				Start	End
Item	Slope Stability			39.160285 °	39.160285 °
				-122.913481 °	-122.913481 °
DWR ID	DWR_NA0009_01_s_2013_13				
Comment Code					
S3 : Repair the levee slope damaged by vehicle traffic and prevent access where possible.					
Inspector Comment

View of the vehicle erosion along the waterside slope.

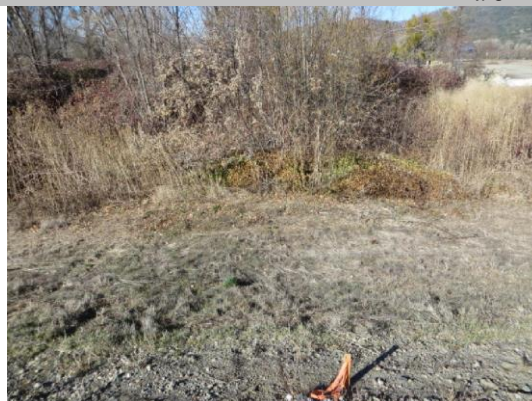
Photo 1 of 2 : UCIP_FA_2016_27004_49862.jpg

LM Start	2.35	Rating **	M	Issue No.	537
LM End	2.35	Issue Type +	En	Location *	WS
Category	Supplemental			GPS Latitude/Longitude	
				Start	End
Item	DWR UCIP Field Study			39.161002 °	39.161002 °
				-122.912843 °	-122.912843 °
DWR ID					
Comment Code					
Inspector Comment					
FS_ID:27004 DS_ID:21199 EP_NO: 11460 Repair Type: Non-Urgent Crossing Status: Found UCIP Comments: Heavy vegetation on LS at inlet should be removed. FIELD_STRUCT_DESC: 42-inch CM drainpipe through the levee, 10.0 feet below the crown. Flap gate on waterward end. Concrete headwall on both ends. Originally included in 1961 O+M manual. Pipe retained under ABO No. 11460 (1975). FS Date: 1/14/2014

Heavy vegetation at inlet on LS toe.

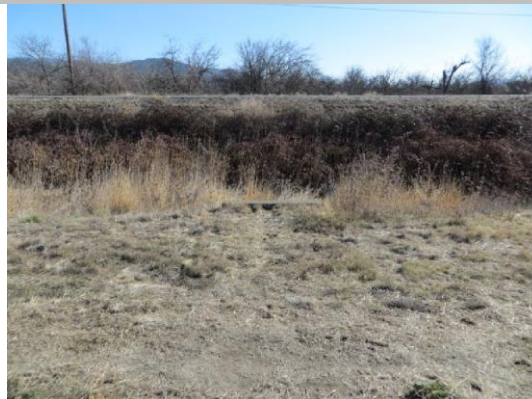
Photo 2 of 2 : UCIP_FA_2016_27004_49861.jpg

Concrete U-shaped headwall on WS berm.

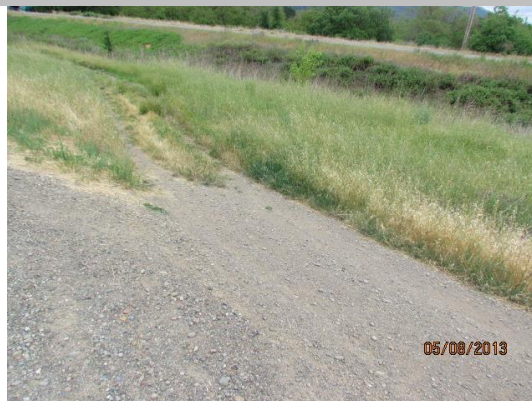
Photo 1 of 1 : FA_2016_NA0009_3_14_20160823_00008.jpg

LM Start	2.36	Rating **	M	Issue No.	14
LM End	2.36	Issue Type +	Ma	Location *	WS
Category	Earthen Levee			GPS Latitude/Longitude	
				Start	End
Item	Slope Stability			39.161153 °	39.161153 °
				-122.912740 °	-122.912740 °
DWR ID	DWR_NA0009_01_s_2013_14				
Comment Code					
S3 : Repair the levee slope damaged by vehicle traffic and prevent access where possible.					
Inspector Comment

View of the vehicle erosion along the waterside slope.

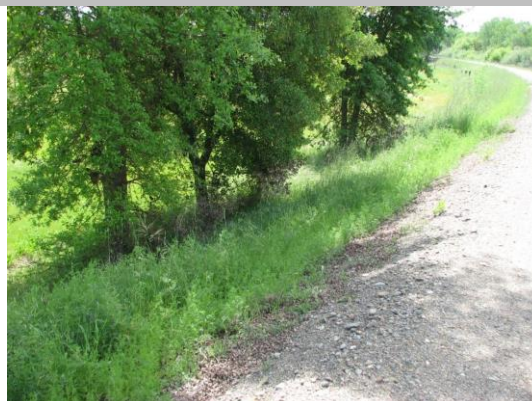
Photo 1 of 1 : FA_2016_NA0009_3_25_20160823_00015.jpg

LM Start	2.95	Rating **	M	Issue No.	25
LM End	2.95	Issue Type +	Ma	Location *	LS
Category	Earthen Levee			GPS Latitude/Longitude	
				Start	End
Item	Trim / Thin Trees			39.155301 °	39.155301 °
				-122.914633 °	-122.914633 °
DWR ID	DWR_NA0009_01_s_2016_25				
Comment Code					
T1 : Trim trees to at least five feet above ground level.					
Inspector Comment

Trim trees to 5' above levee slope (LS). 4/19/2016

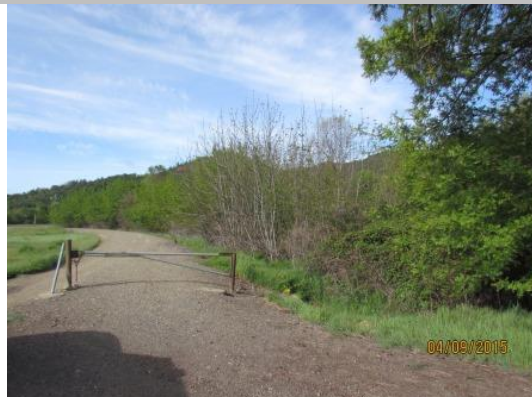
Photo 1 of 1 : FA_2016_NA0009_4_9_20160823_00007.jpg

View of the overgrown trees and vegetation at the landside toe.

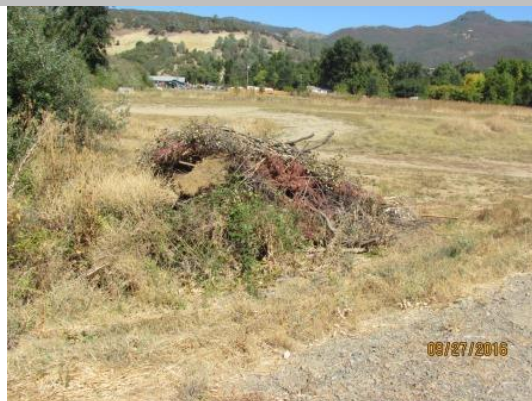
Photo 1 of 1 : FA_2016_NA0009_4_17_20161003_00035.jpg

LM Start	0.38	Rating **	M	Issue No.	17
LM End	0.38	Issue Type +	Ma	Location *	LS
Category	Earthen Levee			GPS Latitude/Longitude	
				Start	End
Item	Encroachments			39.185239 °	39.185239 °
				-122.911018 °	-122.911018 °
DWR ID	DWR_NA0009_02_f_ 2016_17				
Comment Code					
PR : Prunings					
Inspector Comment

View of the prunings along the landside toe.

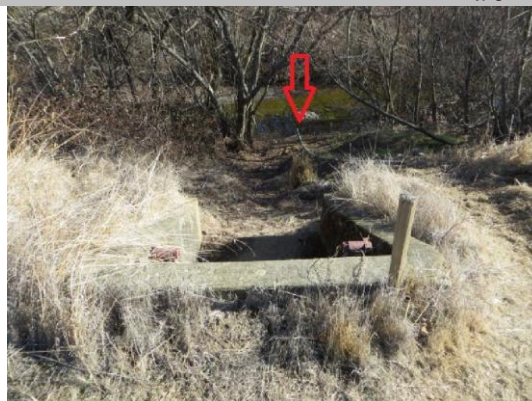
Photo 1 of 2 : UCIP_FA_2016_27563_51182.jpg

LM Start	0.48	Rating **	M	Issue No.	27
LM End	0.48	Issue Type +	En	Location *	LS
Category	Supplemental			GPS Latitude/Longitude	
				Start	End
Item	DWR UCIP Field Study			39.184080 °	39.184080 °
				-122.912130 °	-122.912130 °
DWR ID					
Comment Code					
Inspector Comment					
FS_ID:27563 DS_ID:24761 EP_NO: N/A Repair Type: Non-Urgent Crossing Status: Found UCIP Comments: No Permit identified for crossing. FIELD_STRUCT_DESC: 1.5-inch HDPE irrigation pipe through the levee at unknown depth below the crown. Pipe visible on WS berm slope. Pumphouse on LS toe. FS Date: 1/14/2014 7:19:18 AM

Pipe visible just downstream from stormdrain.

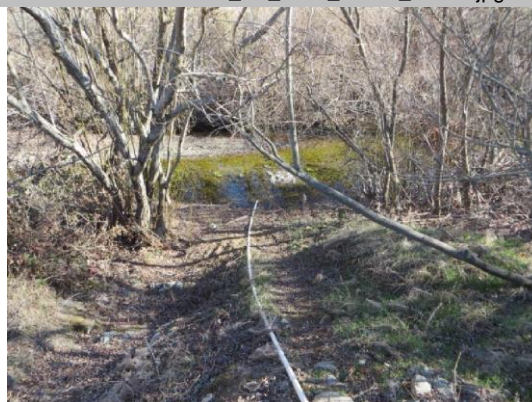
Photo 2 of 2 : UCIP_FA_2016_27563_51181.jpg

Pipe visible just downstream from stormdrain.

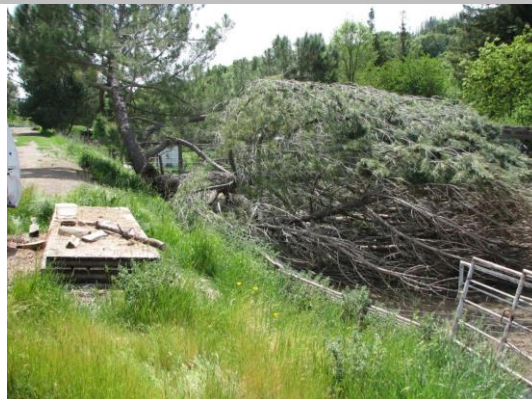
Photo 1 of 1 : FA_2016_NA0009_4_20_20160823_00011.jpg

View of the fallen tree branch on landside slope and toe.

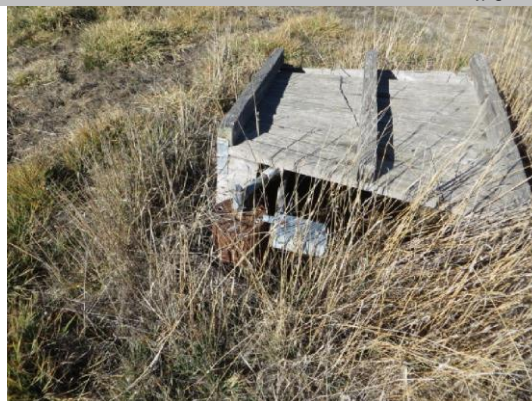
Photo 1 of 2 : UCIP_FA_2016_43053_50393.jpg

LM Start	0.50	Rating **	U	Issue No.	34
LM End	0.50	Issue Type +	En	Location *	LS
Category	Supplemental			GPS Latitude/Longitude	
				Start	End
Item	DWR UCIP Field Study			39.183775 °	39.183775 °
				-122.912187 °	-122.912187 °
DWR ID					
Comment Code					
Inspector Comment					
FS_ID:43053 DS_ID:21209 EP_NO: 8513 Repair Type: Urgent Crossing Status: Found UCIP Comments: Appears pipe is leaking on WS toe of Levee at mud pit FIELD_STRUCT_DESC: 1 of 2: 1.25-inch steel pipe through the levee, 2.0 feet below the levee. Steel cutoff wall around pipe at center of levee. Well with 8-inch casing on waterward slope. (Permit No. 8513-1974) FS Date: 1/14/2014

Pump and pipe visible at wooden box on WS berm.

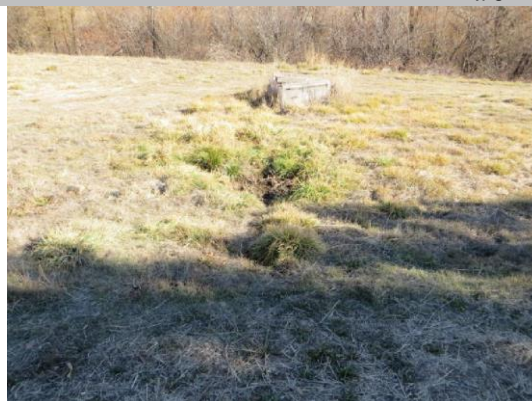
Photo 2 of 2 : UCIP_FA_2016_43053_50392.jpg

Mudpit at WS berm where pipe may be leaking.

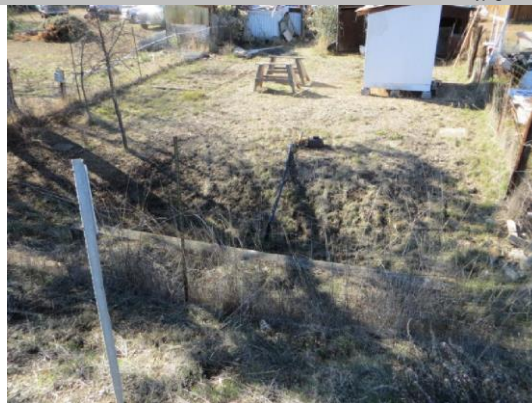
Photo 1 of 2 : UCIP_FA_2016_27208_50411.jpg

LM Start	0.55	Rating **	M	Issue No.	33
LM End	0.55	Issue Type +	En	Location *	LS
Category	Supplemental			GPS Latitude/Longitude	
				Start	End
Item	DWR UCIP Field Study			39.183130 °	39.183130 °
				-122.912198 °	-122.912198 °
DWR ID					
Comment Code					
Inspector Comment					
FS_ID:27208					
DS_ID:21210					
EP_NO: 11482					
Repair Type: Non-Urgent					
Crossing Status: Found					
UCIP Comments: Fence on LS slope creates access issue.					
FIELD_STRUCT_DESC: 36-inch CM drainpipe through the levee, 9.0 feet below the crown. Flap gate on the waterward end. Concrete headwalls on both ends. (USACE-1961). This entry matches the Drainage or Irrigation Structure referenced in O&M manual (HLM 0.54). This pipe was retained under ABO No. 11482 (1975).					
FS Date: 1/14/2014

Concrete headwall on LS toe.

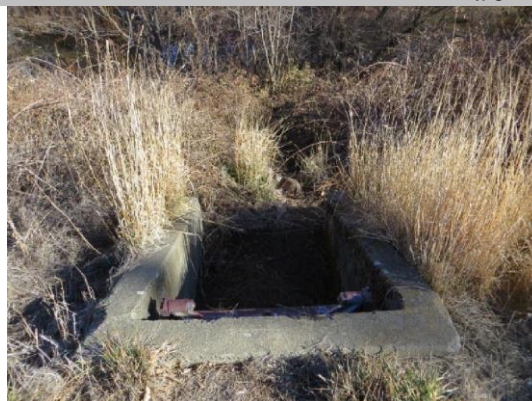
Photo 2 of 2 : UCIP_FA_2016_27208_50410.jpg

Flapgate and concrete headwall on WS berm.

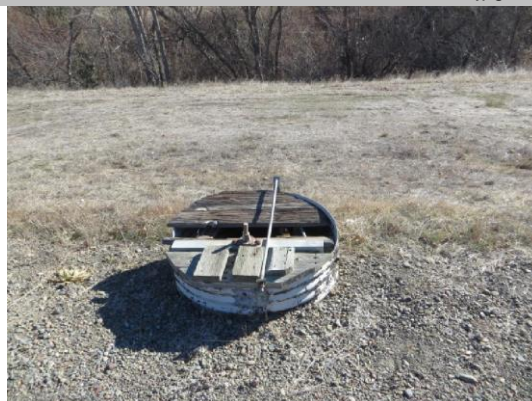
Photo 1 of 2 : UCIP_FA_2016_42994_51214.jpg

LM Start	1.16	Rating **	M	Issue No.	35
LM End	1.16	Issue Type +	En	Location *	LS
Category	Supplemental			GPS Latitude/Longitude	
				Start	End
Item	DWR UCIP Field Study			39.174370 °	39.174370 °
				-122.913543 °	-122.913543 °
DWR ID					
Comment Code					
Inspector Comment					
FS_ID:42994					
DS_ID:21212					
EP_NO: 11483					
Repair Type: Non-Urgent					
Crossing Status: Found					
UCIP Comments: Pipe appears abandoned and if so, should be done so properly. Debris blocking flapgate at outlet.					
FIELD_STRUCT_DESC: *ABANDONED* 30-inch CM drainpipe through the levee, 17.8 feet below the crown. Slide gate in 44-inch diameter CMP riser waterward slope. Flap gate on the waterward end at concrete headwall. 6'X8' concrete sump at landward toe. (USACE-1961). Originally included in O&M manual (HLM 1.22). This pipe was retained under ABO No. 11483 (1975).					
FS Date: 1/22/2014

Slide gate in 44-inch CMP riser on WS shoulder.

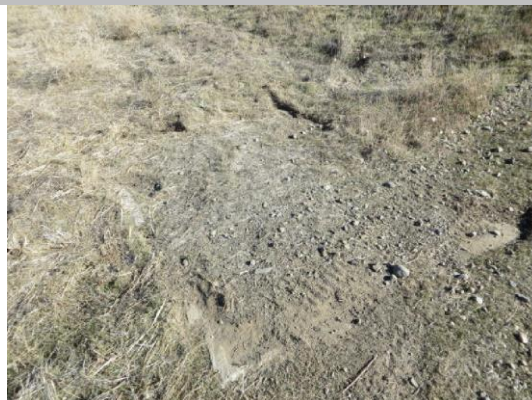
Photo 2 of 2 : UCIP_FA_2016_42994_51213.jpg

6'X8' concrete sump filled in with soil, visible at LS toe.

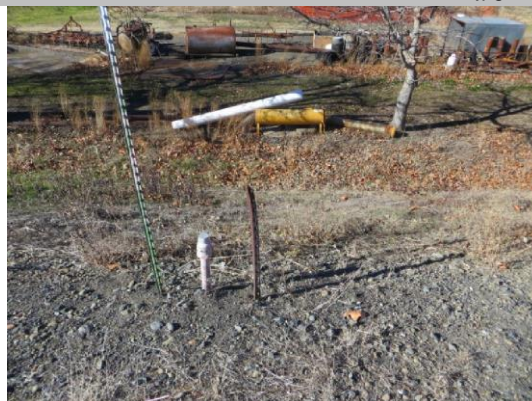
Photo 1 of 2 : UCIP_FA_2016_27606_51250.jpg

LM Start	1.70	Rating **	M	Issue No.	28
LM End	1.70	Issue Type +	En	Location *	LS
Category	Supplemental			GPS Latitude/Longitude	
				Start	End
Item	DWR UCIP Field Study			39.167156 °	39.167156 °
				-122.916610 °	-122.916610 °
DWR ID					
Comment Code					
Inspector Comment					
FS_ID:27606					
DS_ID:21214					
EP_NO: 15825					
Repair Type: Non-Urgent					
Crossing Status: Found					
UCIP Comments: Pipe with closure device not visible on WS toe. Clear soil from pipe and cover for better verification of closure.					
FIELD_STRUCT_DESC: 8-inch steel pipe through the levee, 2.0 feet below the crown. Siphon breaker on apex of pipe at landward shoulder.					
Exposed filter at landward slope. Seasonal pump on waterward slope.					
(Permit No. 15825-1992)					
FS Date: 1/22/2014

Vent on LS shoulder with filter visible on LS toe.

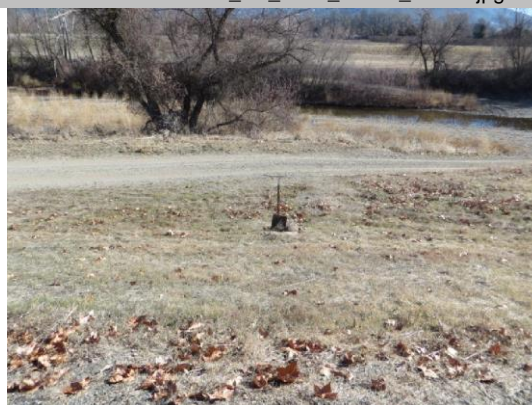
Photo 2 of 2 : UCIP_FA_2016_27606_51249.jpg

T-post at WS toe may indicate location of pipe end. Covered with soil.

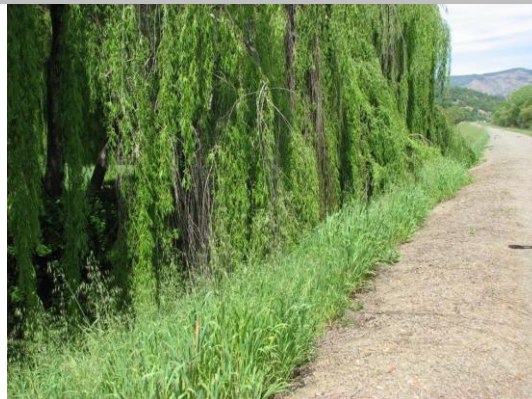
Photo 1 of 1 : FA_2016_NA0009_4_18_20160823_00009.jpg

View of the overgrown willow trees at the landside levee slope.

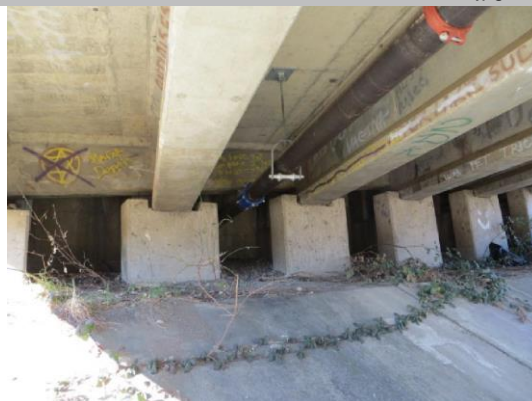
Photo 1 of 2 : UCIP_FA_2016_27624_51263.jpg

LM Start	1.96	Rating **	M	Issue No.	30
LM End	1.96	Issue Type +	En	Location *	LS
Category	Supplemental			GPS Latitude/Longitude	
				Start	End
Item	DWR UCIP Field Study			39.163414 °	39.163414 °
				-122.916741 °	-122.916741 °
DWR ID					
Comment Code					
Inspector Comment					
FS_ID:27624					
DS_ID:21243					
EP_NO: 15865					
Repair Type: Non-Urgent					
Crossing Status: Found					
UCIP Comments: Permit number likely revised from 15865. Verify with inspector and modify entry as required.					
FIELD_STRUCT_DESC: 8-inch steel sewer line (pressurized) through the levee, 3.0 feet below the crown. Cutoff wall around pipe at center of levee. Siphon breaker on waterward levee shoulder. Pipe visible under bridge (Permit No. 15865-1991).					
FS Date: 1/22/2014

Pipe visible under bridge.

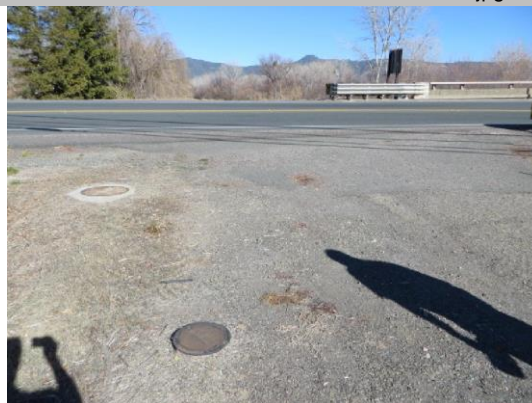
Photo 2 of 2 : UCIP_FA_2016_27624_51262.jpg

Manhole and vent lids visible on LS shoulder.

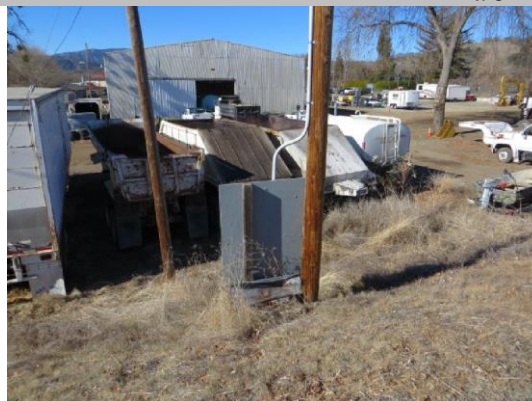
Photo 1 of 2 : UCIP_FA_2016_27629_51280.jpg

FS_ID:27629
DS_ID:21250
EP_NO: 17191
Repair Type: Non-Urgent
Crossing Status: Found
UCIP Comments: Appears abandoned, if so it should be done so properly.
FIELD_STRUCT_DESC: 2 of 2: 2-inch PVC pipe through the levee, 2.0 feet below the crown. Well and electric pump at waterward toe. Pole and meter(Permit No. 17191-2000)
FS Date: 1/22/2014

Meter and control on LS slope next to pole.

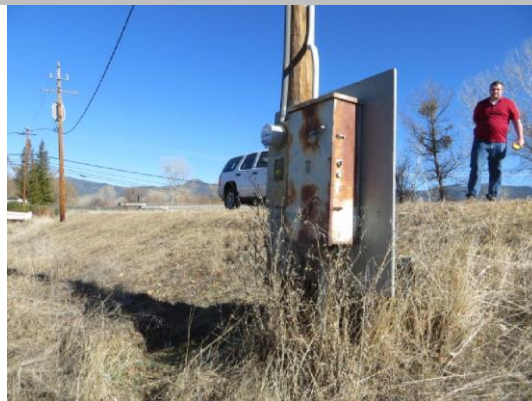
Photo 2 of 2 : UCIP_FA_2016_27629_51279.jpg

Meter and control on LS slope next to pole.

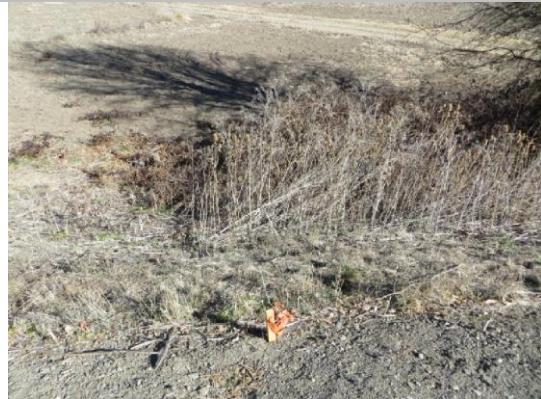
Photo 1 of 2 : UCIP_FA_2016_27863_51542.jpg

Pipe visible at LS toe covered with vegetation.

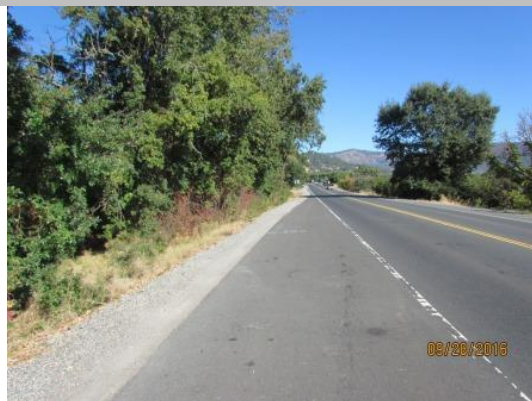
Photo 1 of 1 : FA_2016_NA0009_5_14_20161003_00026.jpg

View of the waterside vegetation looking upstream.

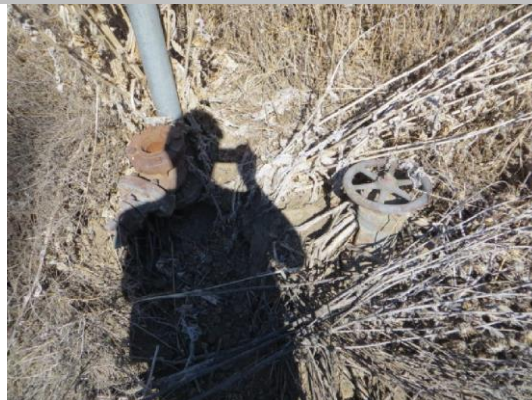
Photo 2 of 2 : UCIP_FA_2016_27903_51621.jpg

Gate valves at tank appear to be in disrepair.

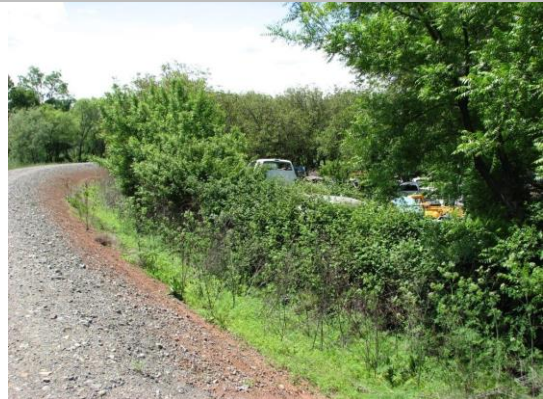
Photo 1 of 1 : FA_2016_NA0009_5_13_20160823_00004.jpg

5/2/2016: Vehicle junk yard behind fence covered in dense growth of bushes and vines.

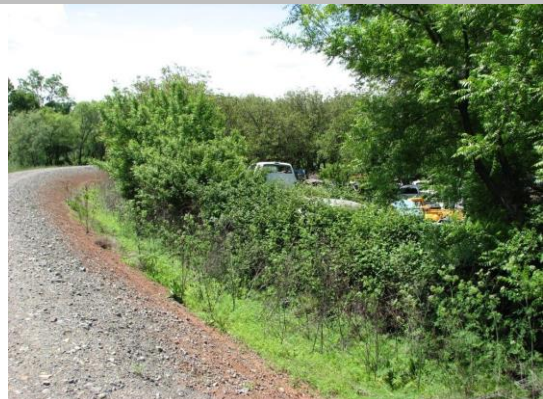
Photo 1 of 1 : FA_2016_NA0009_5_12_20160823_00003.jpg

5/2/2016: Dense bushes and vines covering fence along vehicle junk yard.

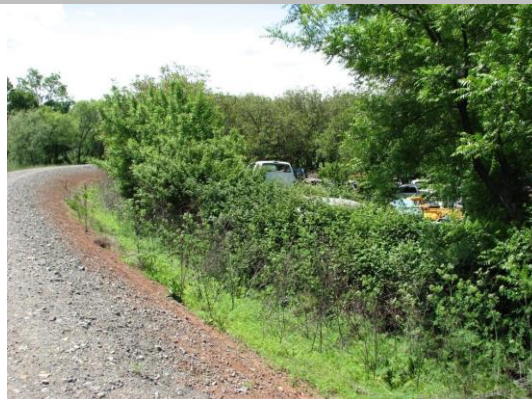
Photo 1 of 1 : FA_2016_NA0009_5_11_20160823_00002.jpg

5/2/2016: Fence along vehicle junk yard is covered in dense growth of bushes and vines.

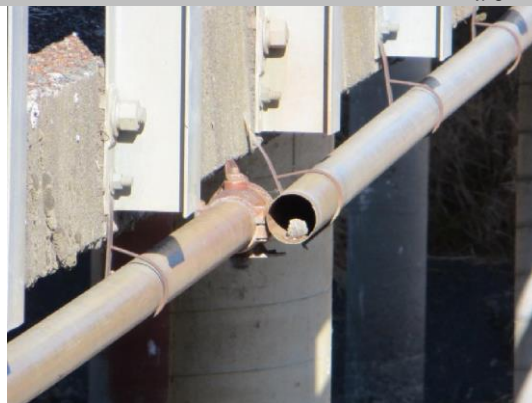
Photo 1 of 2 : UCIP_FA_2016_26907_49751.jpg

Pipe open on waterward end.

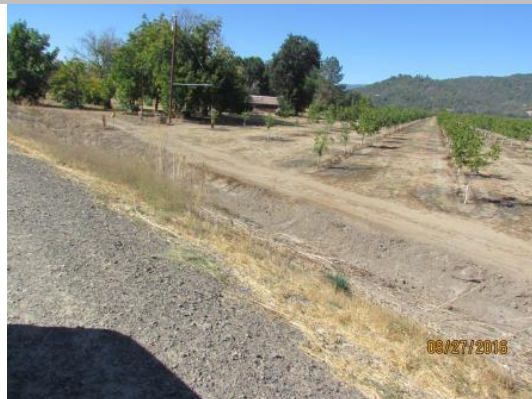
Photo 1 of 1 : FA_2016_NA0009_6_13_20161003_00016.jpg

View of a ditch at the landside toe looking downstream.

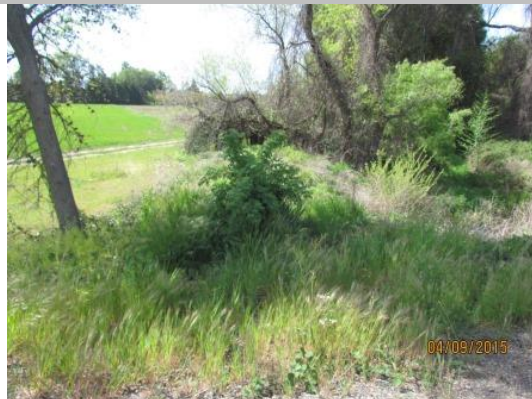
Photo 1 of 1 : FA_2016_NA0009_7_3_20160823_00001.jpg

View of the elderberry along the landside toe.
